System Name: Durham Well Supply  
Municipality: Municipality of West Grey  
Drinking Water System Category: Large Municipal Residential

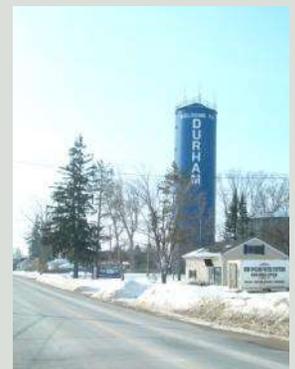
*Durham standpipe*
