**MAP 4.2.G2.3 WELLHEAD VULNERABILITY - CHEPSTOW**

Water Quality - Municipality of Brockton

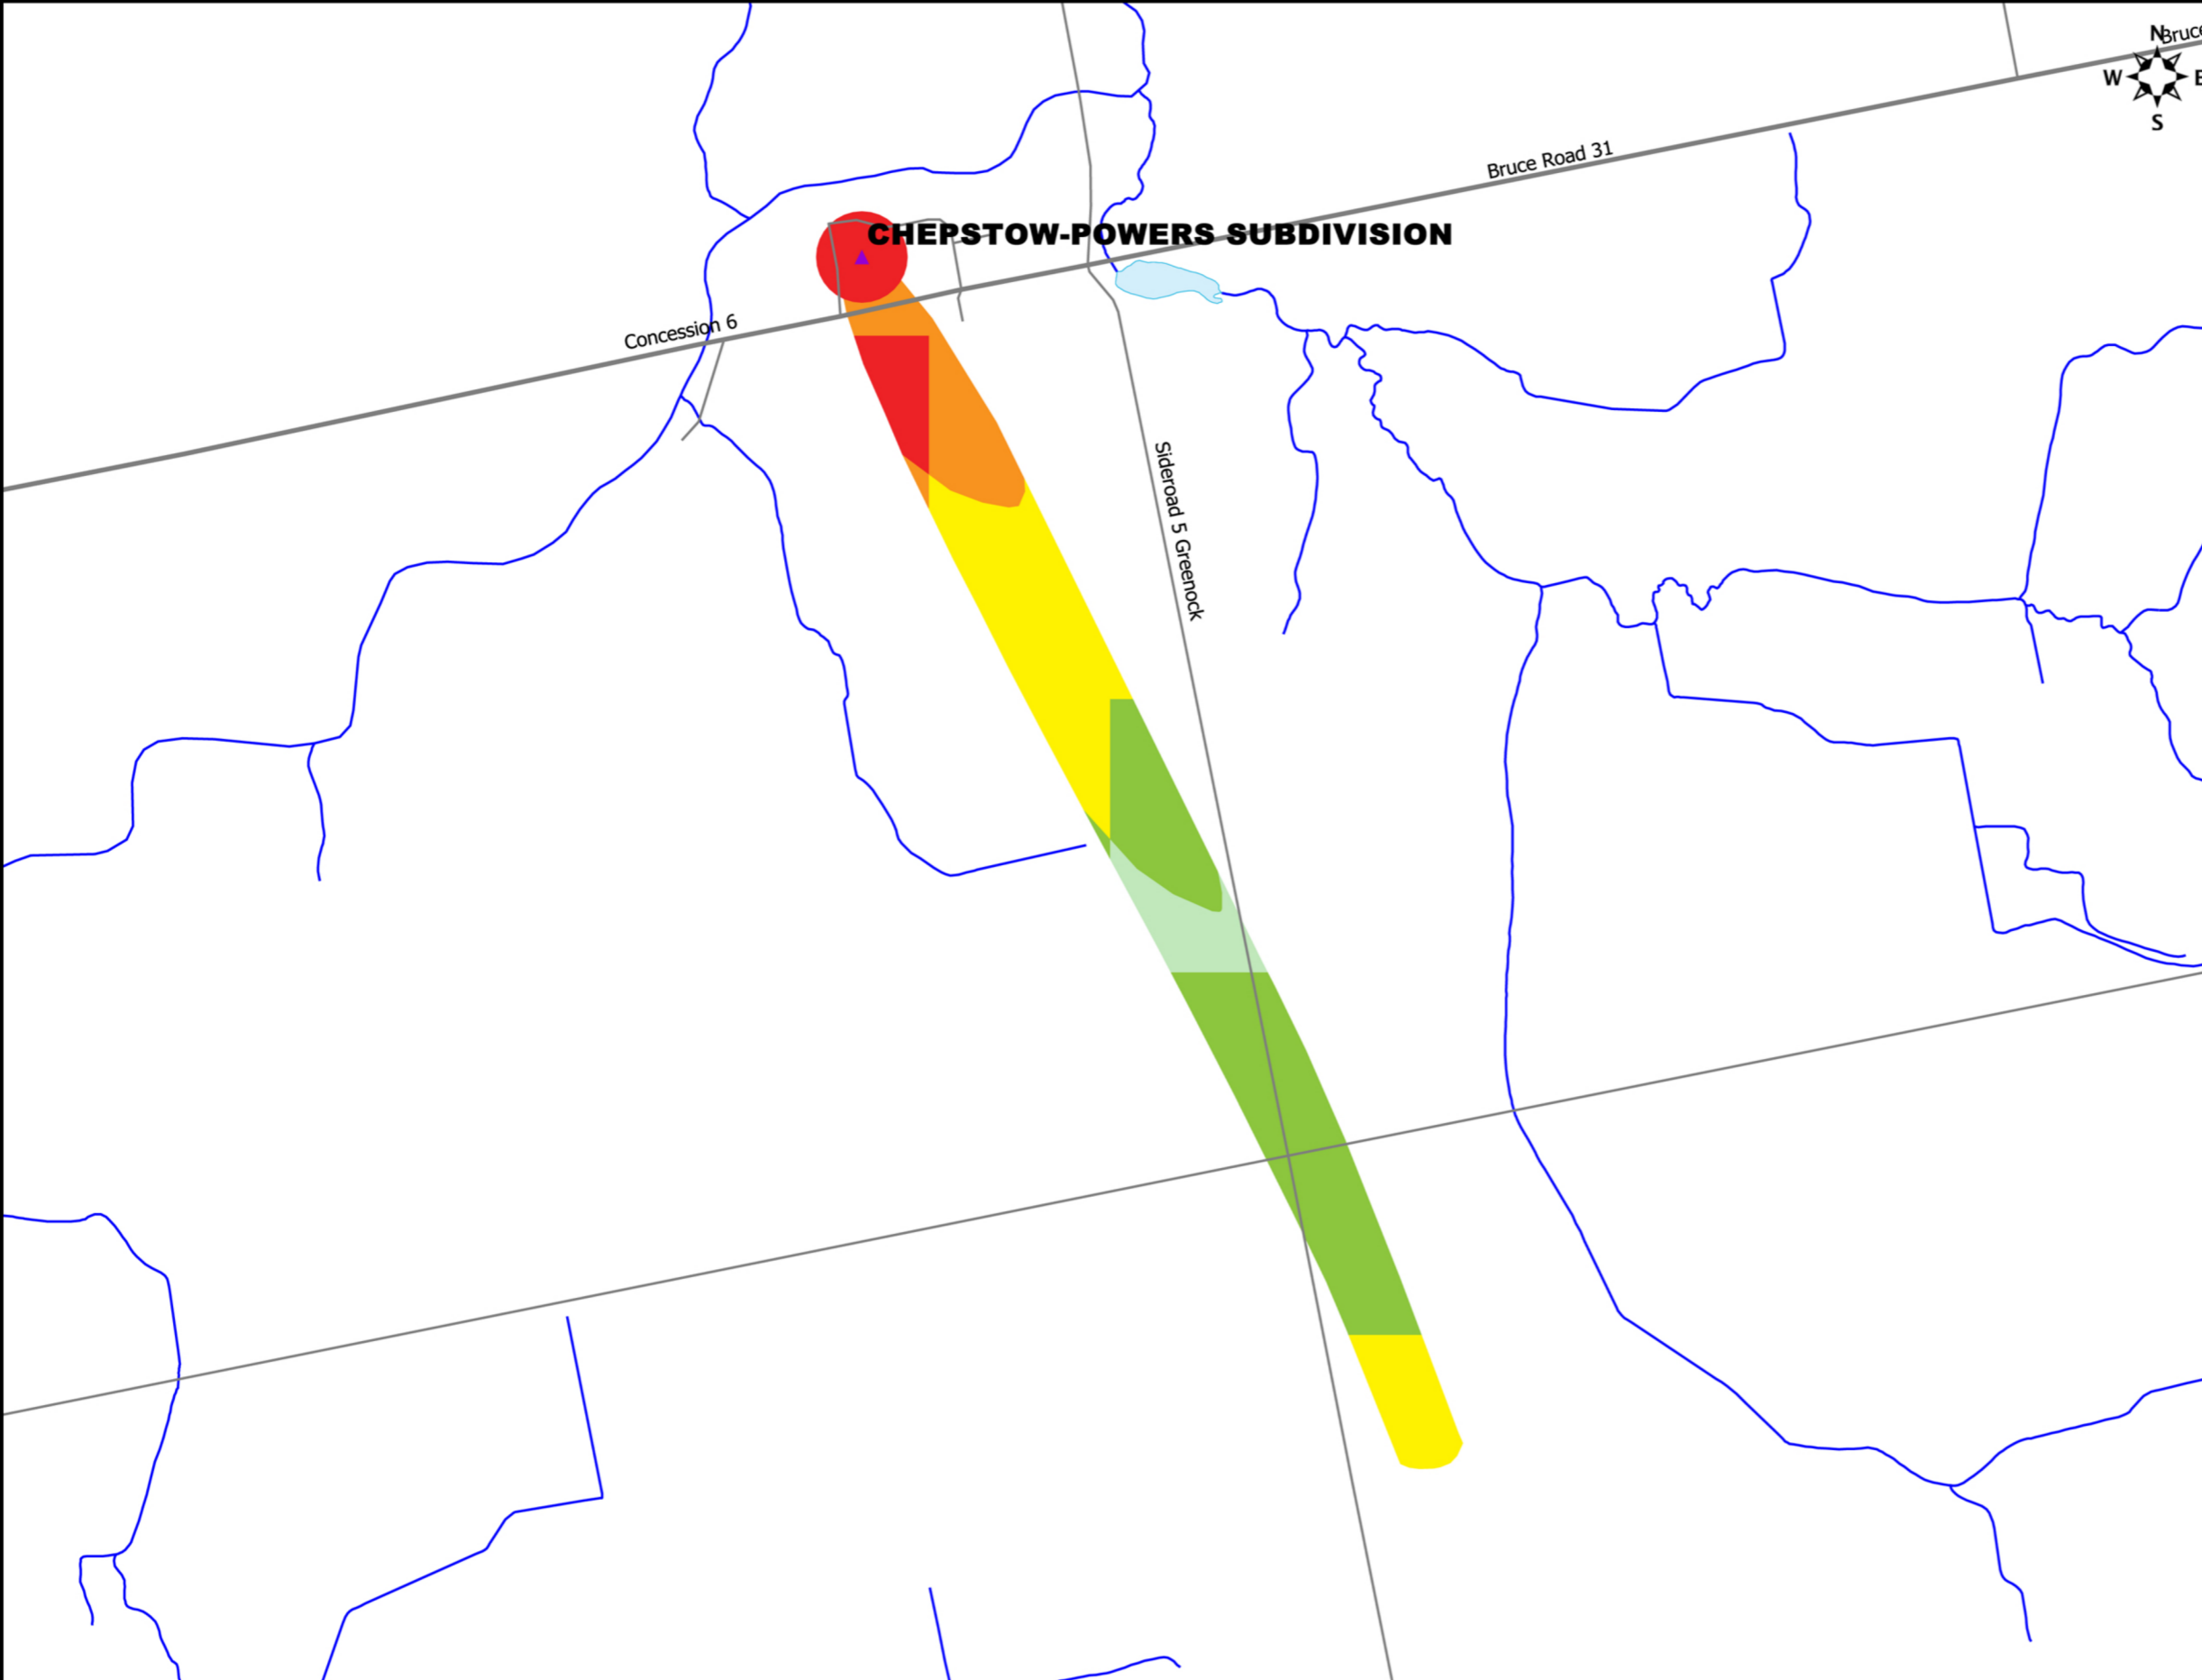
Wellhead Vulnerability Score delineated by Conestoga-Rovers & Associates.

Transport Pathways Score delineated by Conestoga-Rovers & Associates.
