MAP 4.9.S1.4 INTAKE VULNERABILITY - SOUTHAMPTON

Water Quality - Town of Saugeen Shores

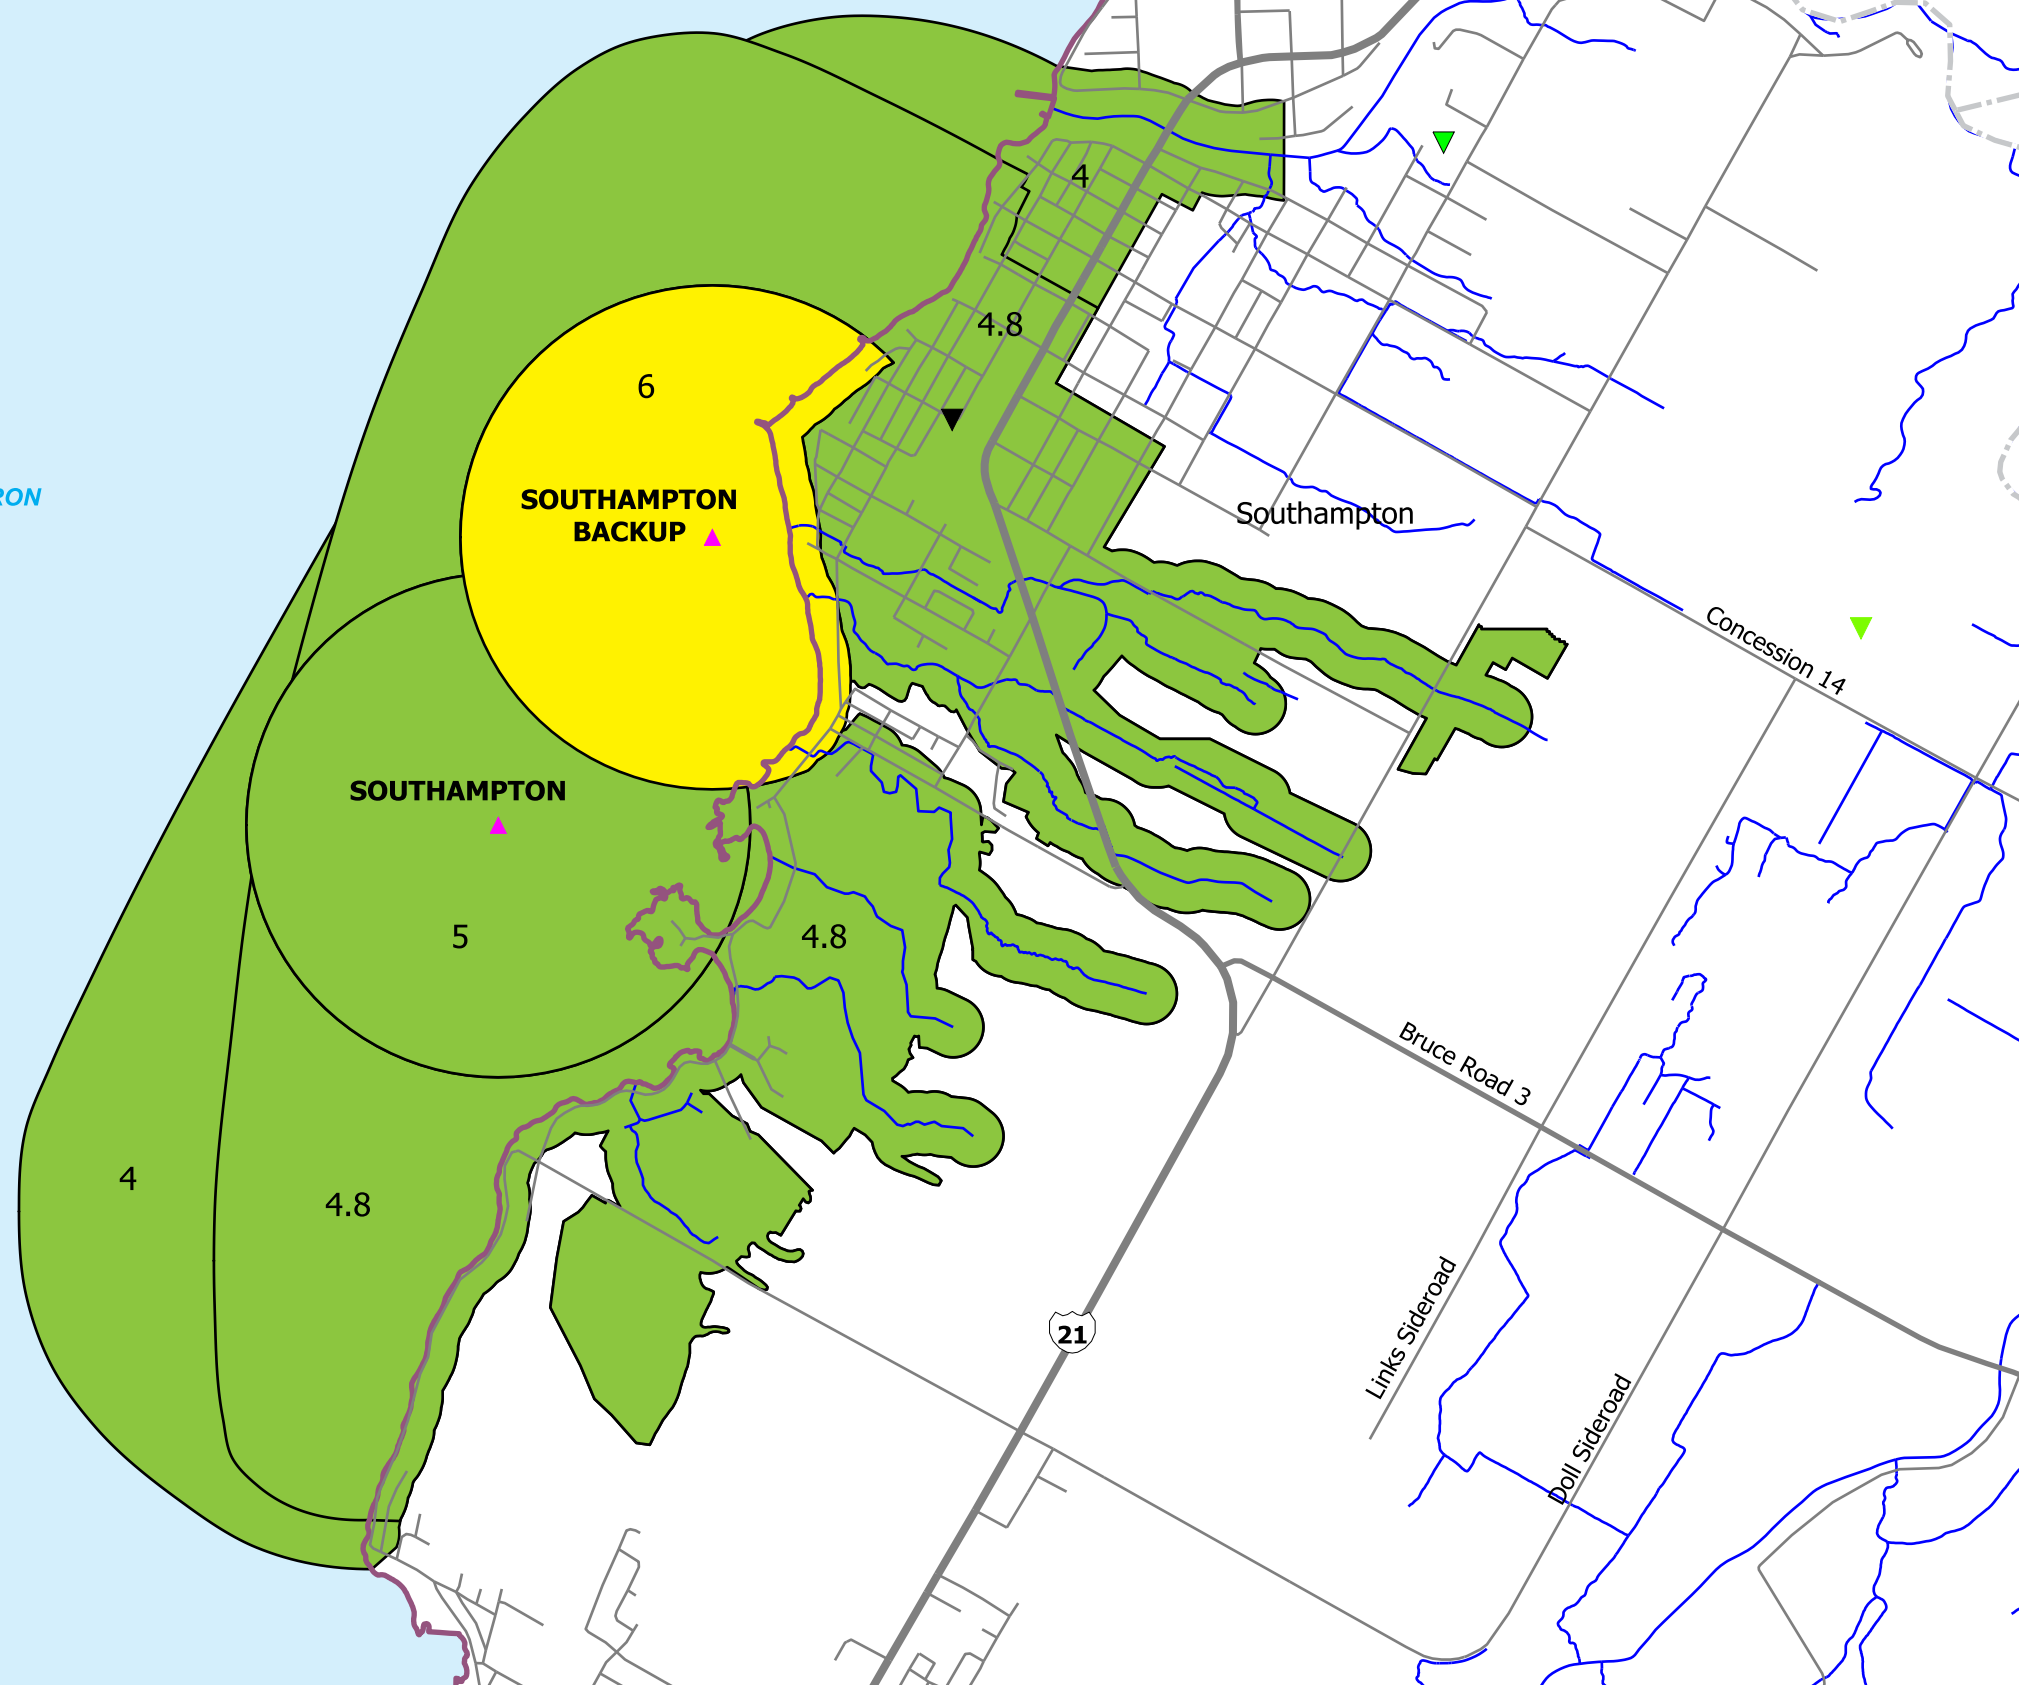
4.8 Vulnerability Score

Vulnerability Score delineated by Stantec.
